Risks in High-Rise Buildings

Report as at
January 2009
on Behalf of
MIA

RISKS IN HIGH RISE BUILDINGS

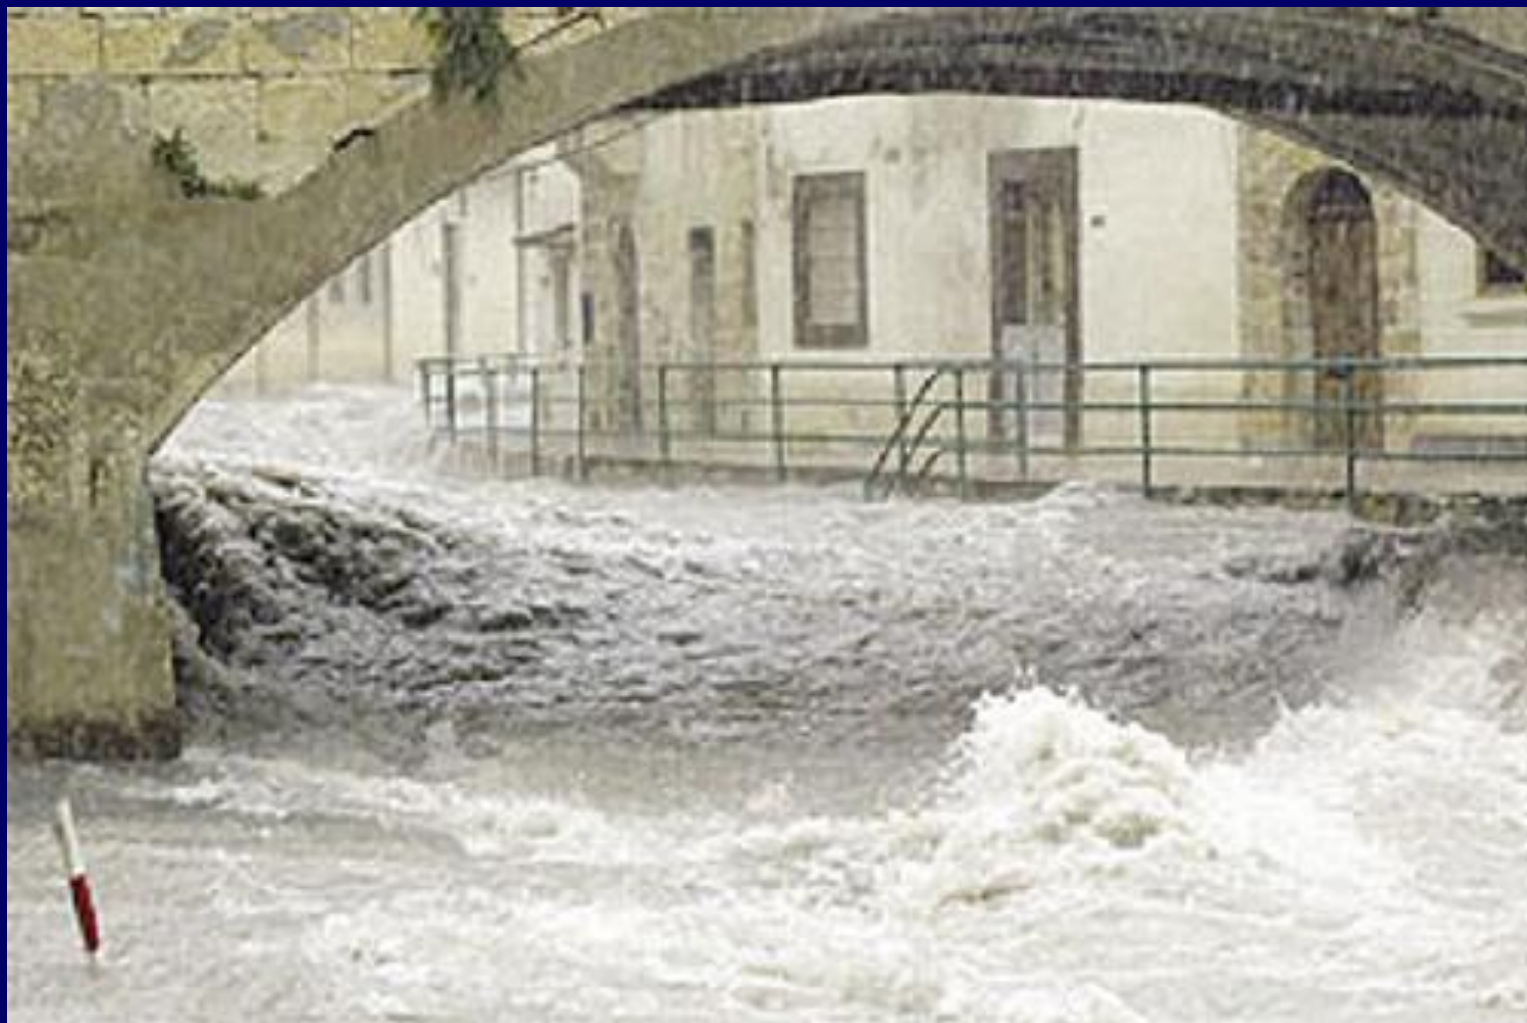
Flash flood at Valley Rd, Birkirkara 4th June 2007 highest recorded for June at 57.6mm in 24 hrs.

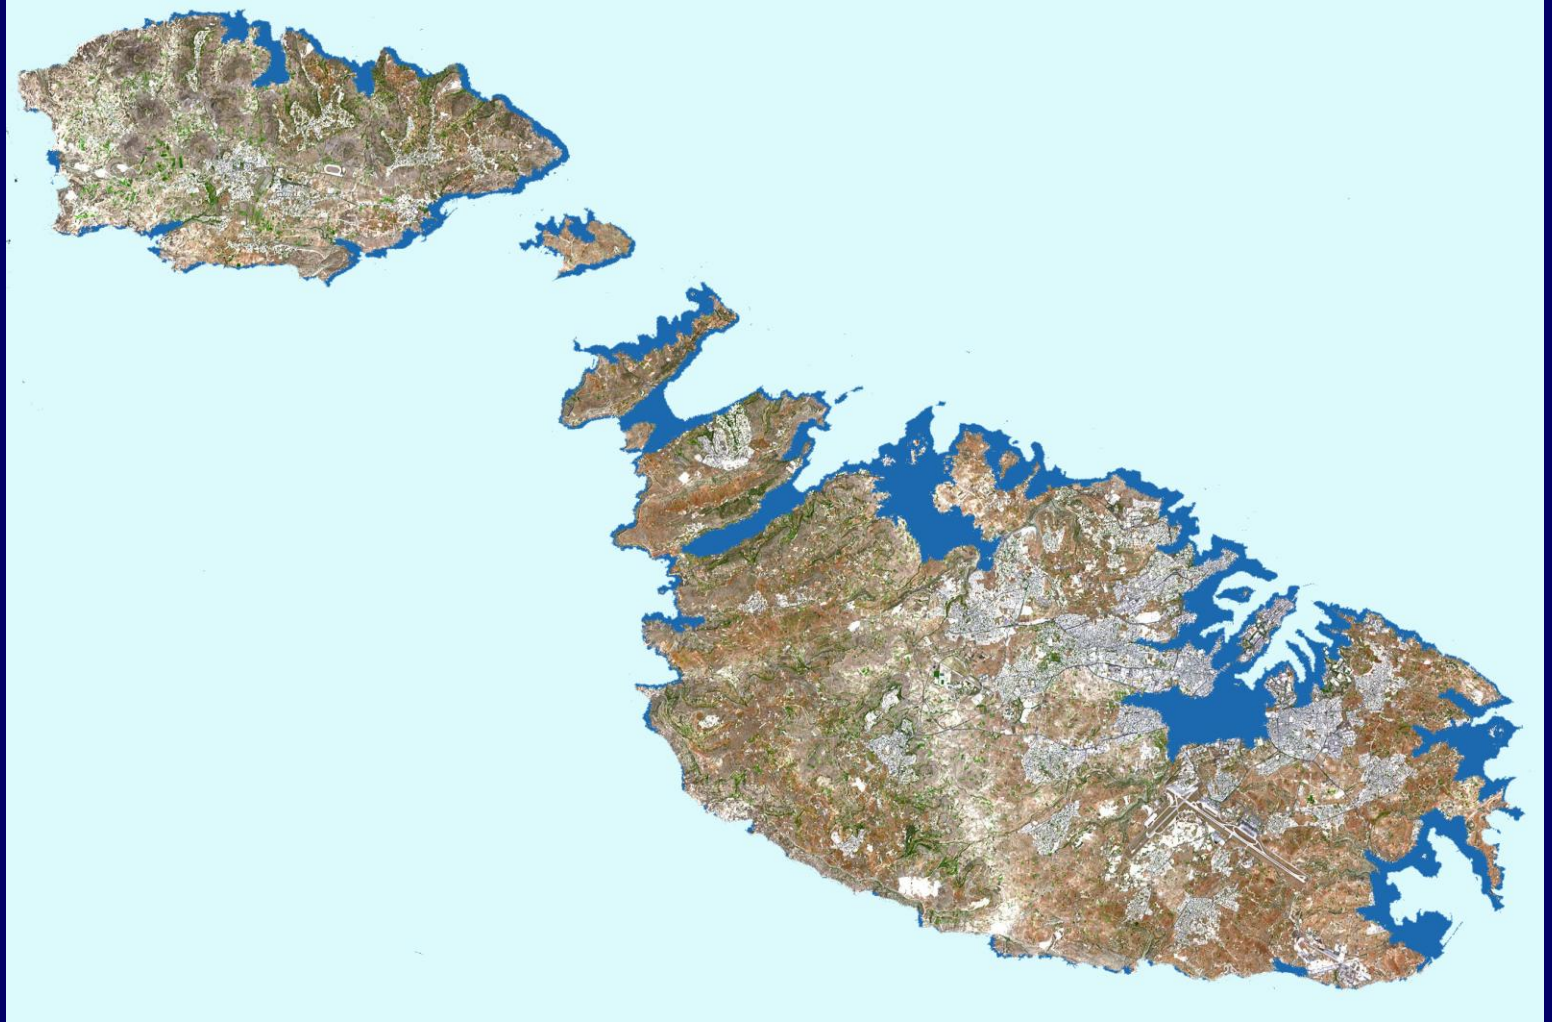
Inundation of the Maltese Islands up to the 10m mark

- The greatest tsunami damage with 7.00m ht run-off is expected from the Aegean Sea with 90min warning
From Eastern Sicily only a 0.5m high run-off is expected with a 50min warning period.
- Greatest Tsunami damage is expected in the Marsa Park & Gzira
- Qawra, Paceville & Tigne has a small fraction exposed, with Luqa outside.

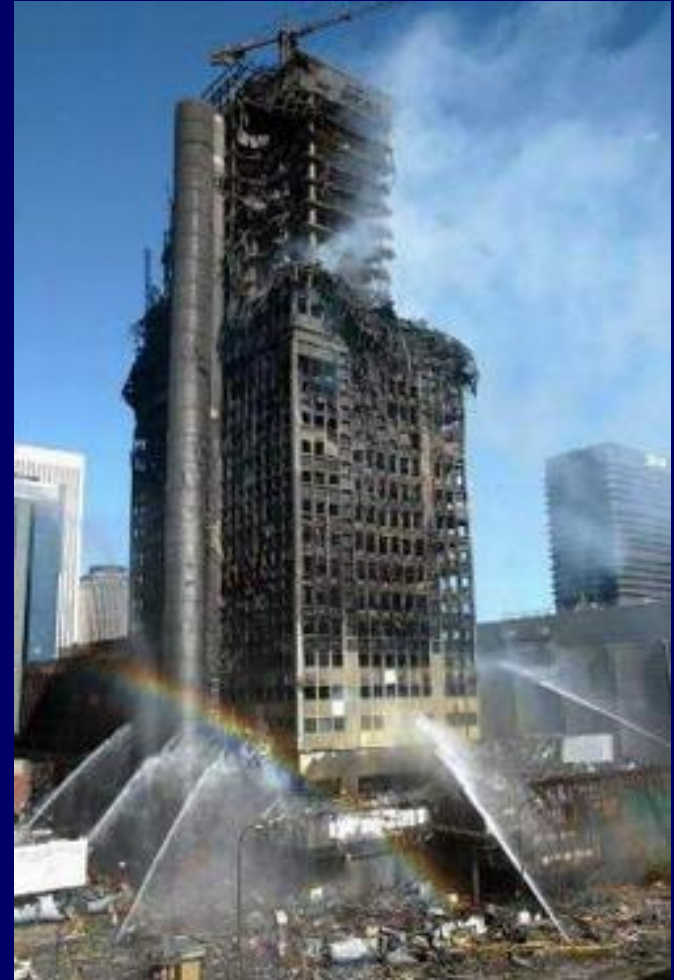
Limitation of fire fighting hose reels noted in the Windsor Building Madrid (Source: Swiss Re)

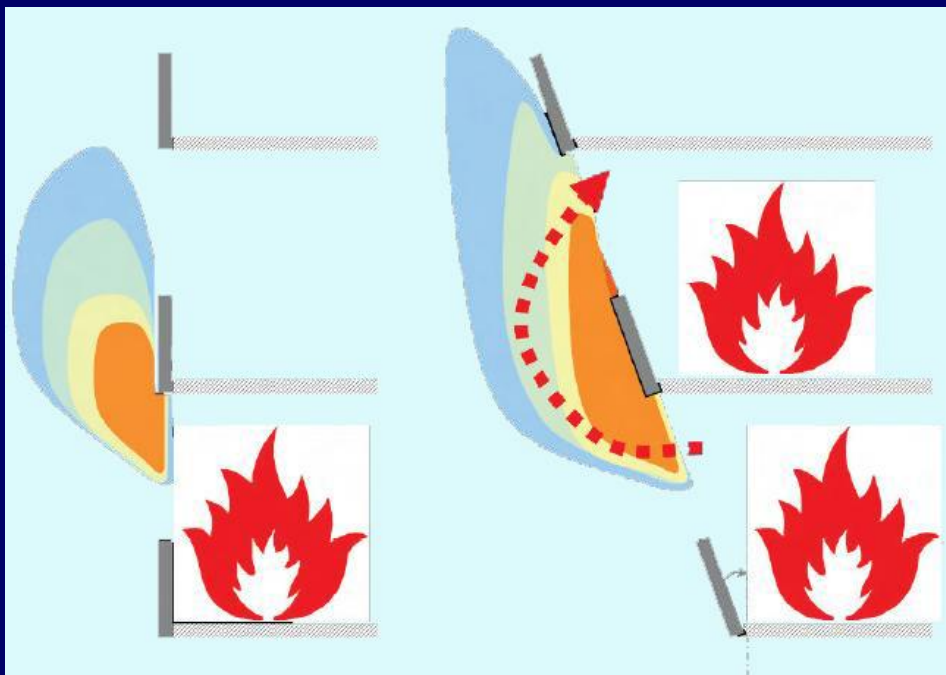
With a simple, vertical façade the cooling as the hot gases leave the fire compartment is such that the potential for re-entrant fire spread is typically low. When the façade is inclined, the region of higher temperature is extended further up the façade and the potential for fire spread is much higher

Further placing sprinklers close to the façade may provide sufficient 'wetting' in the event of a fire, with this approach used instead of alternatively fire-rating a facade
