Allowable Levels of Vibration and Noise in Excavation

Ian Camilleri Cassar
B.E. & A. (Hons.)

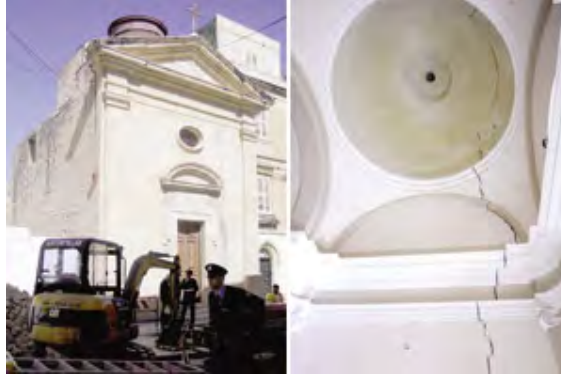
Figure 1.1: Picture of Sliema church and picture of cracks in dome.

Trenching works outside the chapel of Our Lady of Divine Graces in High Street, Sliema, are thought to have caused damage to the early 19th century chapel. Wide cracks have appeared along the walls and the dome of what is thought to be the oldest chapel in Sliema over the past few days following the start of trenching works outside.

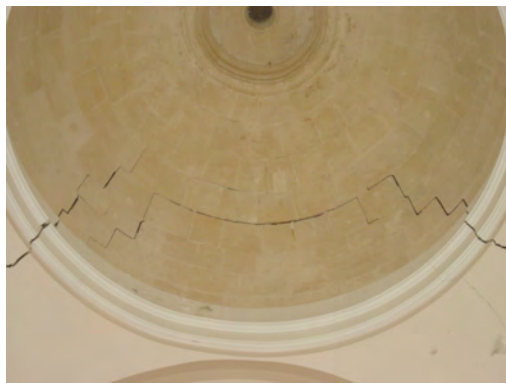
Figure 1.2: Cracks in the dome of Sliema Chapel

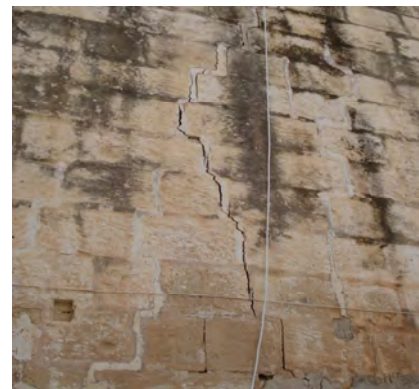
A house situated adjacent to the chapel also sustained structural damage.

Figure 1.3: Cracks on façade of neighboring property.

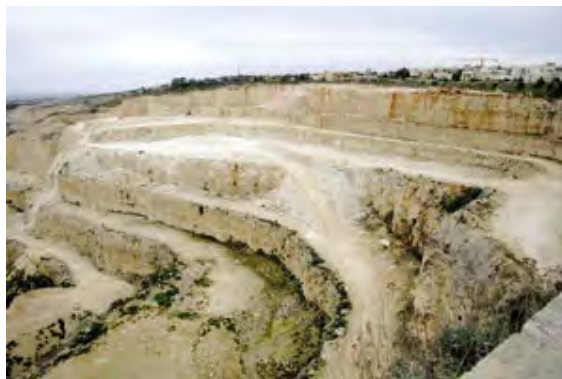
Figure 1.4: Quarry at Naxxar

These huge blasts, with their subsequent vibration, have caused and continue to cause untold damage to property in the area. The large Naxxar water reservoir, down the road from us, is that much closer to the quarries - and sometimes I wonder...!

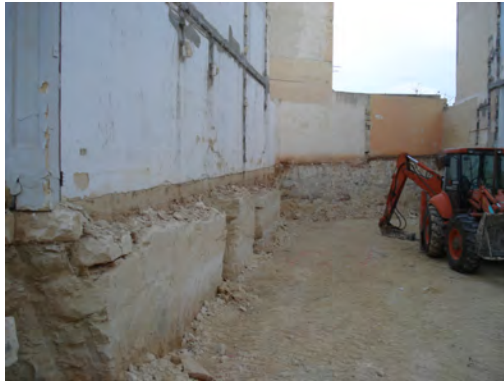
Case 1: Where excavation works are to be carried out in a site surrounded by an existing dwelling or dwellings around its boundary and is to be excavated up to not more than 2 to 2,5m as shown in figure 12.1 the method mentioned before where the site is excavated up to 0.75m from the party wall by using a hydraulic hammer of larger than type 3 from table 9.2 is sufficient enough not to cause any damage to the adjacent building. This is due to resonance not have a serious effect on the premises.

Figure 12.1: 0.75m away from party wall.

Today, in many of the construction sites where excavation work is being done adjacent to party walls, contractors are abiding by the rule of keeping 75cm away from the party wall when it comes to using the hydraulic hammer, and the rest of the 75cm is then removed by using the hydraulic milling cutter. This reduces the amount of vibration that reacts on the wall, and under the adjacent dwelling. This system helps reduce the damage to adjacent dwellings but is only effective up to a certain depth. This system is effective when

excavating up to 2 - 2.5m for a sub-basement but does not make any difference when used in excavation works which go nearly 2 storeys down in line with an adjacent building. In such case, if the rock is weak in that area or the building was built on weak foundations, rock slippage and movement of the building are possible.

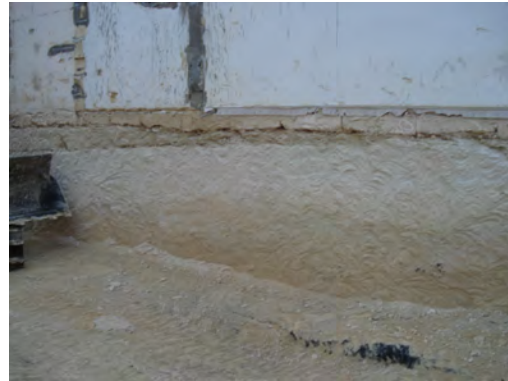
Figure 12.2: Use of hydraulic milling cutter.

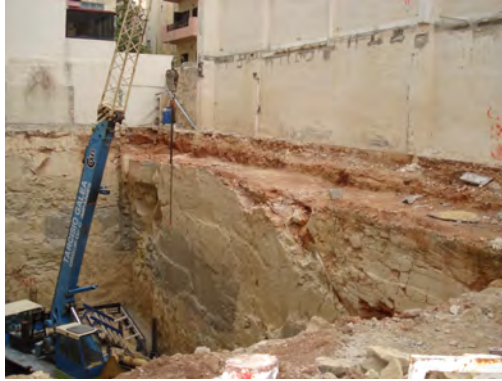
Case 2: In cases where excavation works are to be carried out on a site that is surrounded by third party property along the site perimeter and the excavations are planned to go deeper than 3m from the third party foundation level as shown in figure 12.3 it is suggested that core tests are undertaken before excavation works commence. The core results that show the properties of the existing rock indicate whether to excavate to such a depth. If the core tests show that the rock is strong, excavation works can be carried out. If the rock is weak and highly damaged then it must be the responsibility of the architect-in-charge to take the necessary precautions.

Figure 12.3: 3 stories below street level.

For example, the type of machinery to be used must be chosen diligently. Also, if the rock is highly damaged, it might be better to use anchors in the rock, as one goes deeper. Another precaution may be to prop the site from one side to the next until the new structure is strong and stable enough to take the load itself. It is important to point out that for this to be possible, the site must not be very wide.

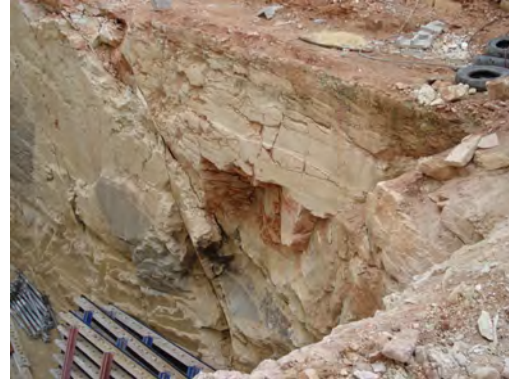
Figure 12.4: Badly fractured rock
